Ng' ambi Immanuel
University of Zambia, School
of Mines, Department of
Mining Engineering, Lusaka,
Zambia

Optimization of stope recovery and dilution at Mufulira mine through application of appropriate designs and practices

Ng' ambi Immanuel and Victor Mutambo

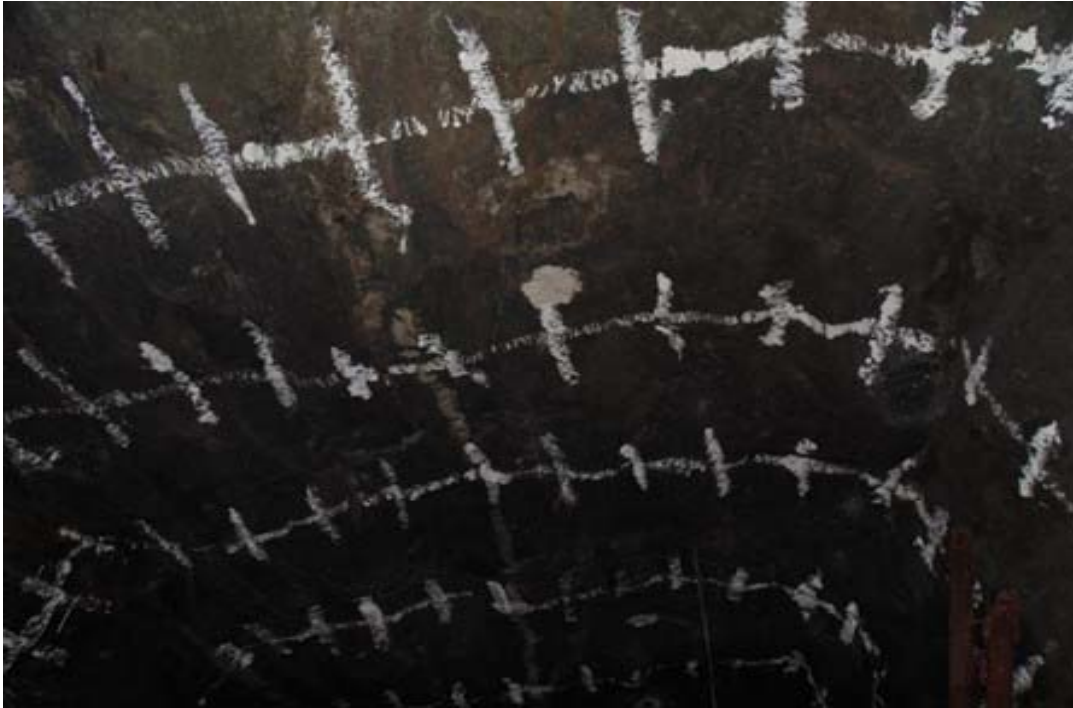
Fig 1: Properly marked rings

In some sections of the mine visited, the longhole rings are not properly marked. Figures 3 and 4 show a comparison between the standard way of marking rings and the actual marking found underground. The ring in figure 4 was poorly marked leading to poorly drilled longholes. Poor drilling of longholes leads to increased toe burdens. This increase in toe burden increases the volume of ore that will have to be blasted by each charged hole and hence creating hang-ups.
