## Evaluation of the anatomic causes for failure of optimum fixation of anterior cervical plate

**Dr. Bias Dev and Dr. Simriti**

The anterior cervical spine surgical procedures invariably need anterior fixation of the vertebral bodies with cervical plates which has a locking mechanism to prevent screw back out. The author encountered the situations in approximately 20 % of his cases where he failed to lock the plate. The cause of failure were evaluated by studying the morphometry of the typical cervical body and it has been found that width of one third of the vertebral bodies were less than the distance between two screw holes, needing medialisation of screws which do not let the locking mechanism to work. The authors recommended manufacture and use of smaller plates for smaller individuals.

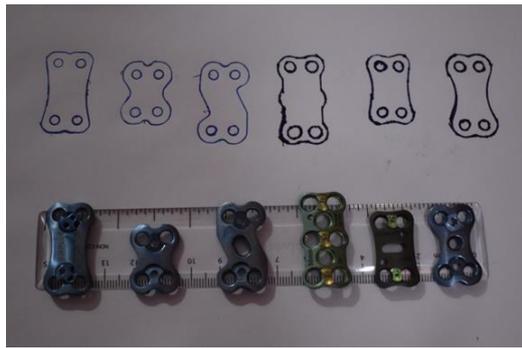
**Fig 1:** Different plates with scale

The cervical spine locking plates were collected from various suppliers and the following dimensions of the plate were noted

The maximum width of the plate  
 Distance between the two screws.

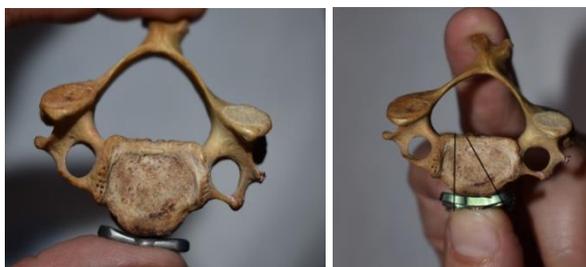
**Fig 2, 3:** Plate position and screw Trajectory

**Fig 4:** Cam rotated over screw heads

**Fig 5:** Inability of cam to rotate over proud screws

We placed the 16, 17, and 18 mm wide plates at the anterior surface of typical cervical vertebrae. The needed trajectory for the purchase of the screw in the vertebral body was assessed. The smaller the body, more medial inclination was needed to avoid lateral perforation of vertebral body or slipping of the screw laterally. On placing the screw tangentially, the screw head stayed prouder than the plate surface. The locking mechanism need the cam to be rotated 180 degree for locking mechanism to act. The cam can rotate only if the hinderance from screw head is not there. Once the screw is prouder than the plate, the cam cannot move over the screw head and hence cannot lock the plate. The unlocked screw is at the risk of backing out.

This problem of prouder screw at plate screw interface was not there if the screw is put straight without angulating it medially, but the smaller vertebral bodies necessitates screws medialisation.

From this study we could understand the reason for incidence of slippage of screws laterally. These screws were medialised and in them there erupted the problem of proud screw heads at plate screw interval, not allowing the locking mechanism to work. The incidence of failure to lock matched with the corresponding smaller number of vertebrae as we have 10 out of 32 vertebrae be smaller than the distance between the two screws which was less in only in one with width of 11 mm where as in 5 other kinds of plates the distance was 12 and 13 mm.
