## Reattachment of fractured anterior tooth using Ribbond and an esthetic post-A case report

### Abstract

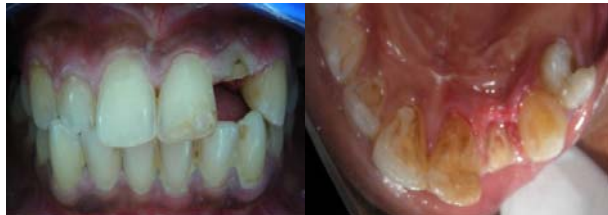
**Fig 1a and 1b:** Clinical presentation of labiopalatal fracture of maxillary left central incisor

A 15 years old female patient reported to the department of Pedodontics, Sri Aurobindo College of dentistry, Indore, with the history of fall and injury to the upper front teeth one day back. Extra-oral examination revealed no significant abnormalities, and intra-oral examination revealed neither lacerations nor evidence of alveolar bone fracture, but there was a fracture line extended from labiopalatally in apical direction in relation to 22 which was supragingival [Figure 1a and 1b]. Based on clinical and radiographic findings, it was diagnosed as Ellis class III fracture in relation to 22. It was planned to perform single visit root canal treatment (RCT) on 22 followed by reattachment of the fractured fragment with fiber post and Ribbond fibers reinforcement. Local anesthesia was administered (1.0 cc of lidocaine 2% with 1: 80,000 epinephrine) and the fractured segment in relation to 22 was atraumatically removed. It was then cleaned with 2% chlorhexidine solution and stored in isotonic saline solution. RCT was completed on 22. Immediate sectional obturation was done using gutta perch and AH plus sealer. (Dentsply Maillefer, Dentsply) and post space was prepared using GG drills and Peeso reamers. Meanwhile the fragment was cleaned of pulp tissue (Figure 2a). Both the intact coronal portion of the tooth and the original crown fragment were etched with 37% phosphoric acid gel for 20sec, rinsed with water for 20 sec and dried with a gentle stream of air, dentin bonding agent (Adper Single Bond Plus, 3M)

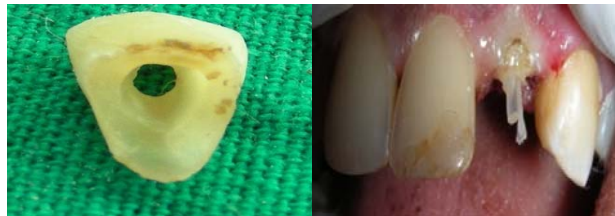
**Fig 2a and 2b:** Fractured fragment cleaned of pulp debris and placement of fiber post with ribbond fiber into the prepared post space

Flowable composite resin (Filtek Supreme XT, 3M) was applied and cured for 40sec. Fragment was positioned to its original place with the help of fiber post (D.T. Light Post Illusion #2, Bisco, Schaumburg, IL, USA) and a strip of Ribbond fiber (Ribbond Inc., Seattle, WA, USA). Excess resin was removed and light cured for 40 seconds. (Figure 2b)

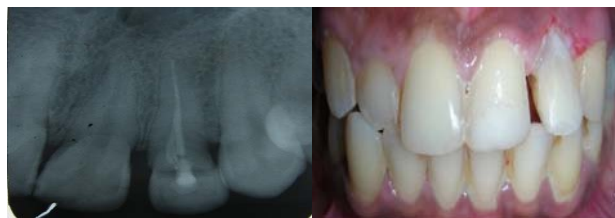
Clinical and radiographical follow-up examination, at 6 months was evaluated: fragment position, fragment stability, gingival swelling, and presence of abscess, sinus tract formation, sensitivity to percussion were normal and satisfactory. (Figure 3a,3b)

**Fig 3a and 3b:** Six months follow up: clinical and radiographic image
